WOOD DESTROYING PESTS AND ORGANISMS INSPECTION REPORT

BUILDING NO. 161,167	STREET, CITY, STATE, ZIP & 173 I STREET, FREMONT CA 94536	Date of Inspection 9/1/2009	No. of Pages 11
--------------------------------	---	---------------------------------------	---------------------------

OMEGA TERMITE CONTROL, Inc.

Firm Registration No. PR 1058	Report No. 72392	Escrow No.
Ordered By: RE REALTY EXPERTS 41051 MISSION BLVD FREMONT, CA 94551 Attn: SUZANNE & MARYANN 226-2432 EMAIL SUZANNE	Property Owner/Party of Interest SONI LEIGHTON *** *,** EMAIL SONI	Report Sent To: RE REALTY EXPERTS 41051 MISSION BLVD FREMONT, CA 94551 Attn: SUZANNE & MARYANN 226-2432 EMAIL SUZANNE

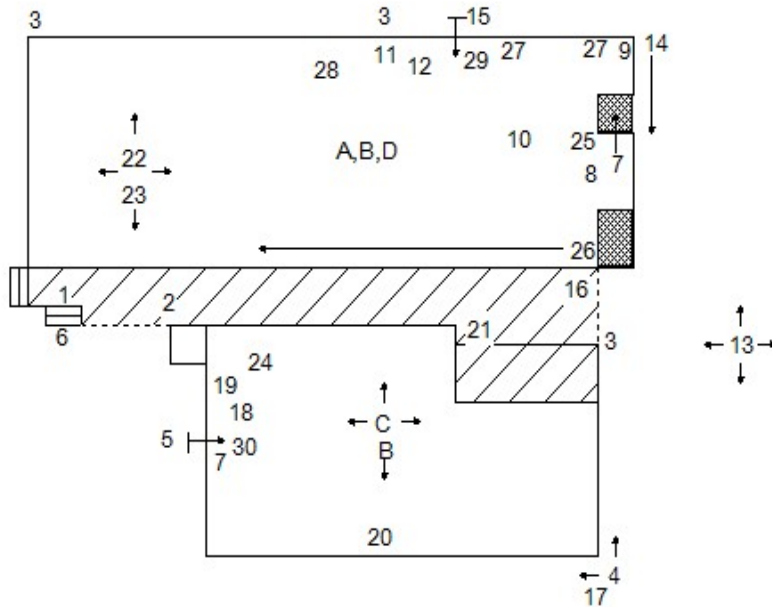
DIAGRAM IS NOT TO SCALE .FINDINGS ARE IN APPROXIMATE LOCATIONS

ITEM 1 FINDING The door threshold and/or casings at the area indicated on the diagram is fungus damaged.

ITEM 3 FINDING Plant growth is abutting the structure at the area(s) indicated on the diagram.

ITEM 4 FINDING A heavy growth of bushes prevented inspection at the area indicated on the diagram.

ITEM 7 FINDING There are dry-wood termite pellets in the window sill, above the door and the substructure at the areas indicated on the diagram.

ITEM 8 FINDING Evidence of a dry-wood termite infestation was found in the area indicated on the diagram.

ITEM 10 FINDING A water stain was noted to the ceiling at the area indicated on the diagram. This condition can possibly be attributed to past or present roof leakage.

ITEM 16 FINDING The wood siding at the area(s) indicated on the diagram is fungus and or subterranean termite damaged.

ITEM 17 FINDING The embedded fence is attached to the structure at the area indicated on the diagram creating an earth-wood contact.

ITEM 18 FINDING The sheet-rock at the area indicated on the diagram is moisture damaged.

ITEM 20 FINDING The window(s) indicated on the diagram are fungus damaged.

ITEM 21 FINDING The wood siding at the area(s) indicated on the diagram is subterranean termite damaged.

ITEM 25 FINDING Subterranean termite migration tubes were found at the areas indicated on the diagram.

ITEM 26 FINDING Fungus damage was found to the substructure framing at the area(s) indicated on the diagram.

ITEM 27 FINDING Fungus damage was found to the substructure framing at the area(s) indicated on the diagram.

RECOMMENDATION Remove the damaged wood members and replace with new material as necessary. Re-seal this area on a one time basis.

RECOMMENDATION The owner should keep all plants trimmed away from the structure to help prevent moisture accumulation and increase air circulation.

RECOMMENDATION We will return to the property and inspect this area, if requested, after the bushes have been trimmed back. This will be done at an additional charge of \$85.00.

RECOMMENDATION Remove and/or cover all accessible termite pellets to aid in future inspections.

RECOMMENDATION Fumigate the structure with Vikane Gas containing Sulfuryl fluoride for the control of these termites. It will be necessary for the property to be vacant for approximately 2 nights in order to undertake this recommendation. Omega Termite Control and the fumigator cannot be held responsible for any damage to the roof covering or plant life around the structure during the course of the work. All reasonable care will be taken to avoid damage of any type. The owner must trim back any bushes which abut the structure and remove all television antennas prior to the fumigation. NOTE AS THIS IS A MULTIPLE DWELLING ALL UNITS WILL NEED TO BE VACATED, AND THE PROPERTY PREPARED BEFORE THE BUILDING CAN BE FUMIGATED. OUR PRICE IS FOR THE ENTIRE STRUCTURE. AFTER THE FUMIGATION IS COMPLETE AND THE PROPERTY IS POSTED SAFE FOR RE-OCCUPANCY, IT IS THE OWNERS RESPONSIBILITY TO TURN THE GAS BACK ON AND RELIGHT THE PILOTS.

RECOMMENDATION The owner should engage the services of a licensed roofing contractor to inspect the condition of the roof covering, gutters and downspouts and make necessary repairs.

RECOMMENDATION Remove the damaged wood members and replace with new material as necessary. Paint to match as closely as possible.

RECOMMENDATION Install metal flashing between the fence and the structure to eliminate this condition.

RECOMMENDATION Repair the sheet-rock as needed. No painting is included.

RECOMMENDATION One of the sashes has leaded stained glass. Our bid does not include reinstalling this particular glass. Omega will have clear glass installed.

RECOMMENDATION Knock down all visible tubes to comply with the Structural Pest Control Act.

RECOMMENDATION Remove the damaged wood members and replace with new material as necessary. The decking will need to be removed from this area as this damage is adjacent and below the decking. Our bid does not include replacing any decking.

RECOMMENDATION Remove the damaged wood members and replace with new material as necessary.
